# Essure Confirmation Testing

# The Essure Confirmation Test Overview

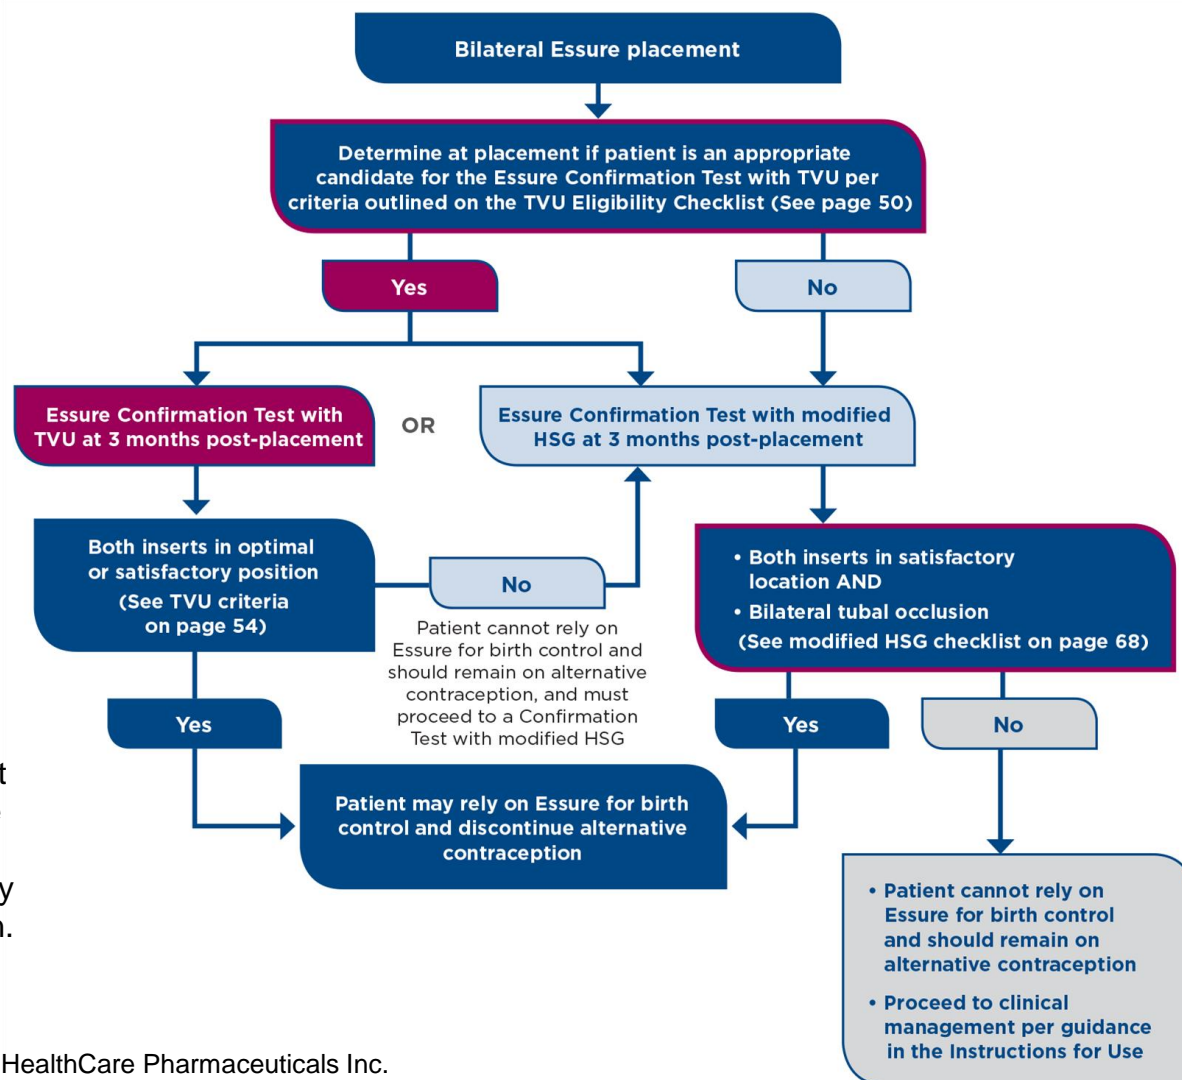
# TVU/HSG Confirmation Test Algorithm

- A modified HSG was the only option in the United States for determining whether a patient can rely on Essure for birth control
- The TVU/HSG Confirmation Test Algorithm:
  - Confirmation Test can be performed using modified HSG or TVU in patients meeting specific criteria
  - If TVU is not indicated, or results are equivocal or unsatisfactory, a modified HSG is required to evaluate insert location and tubal occlusion

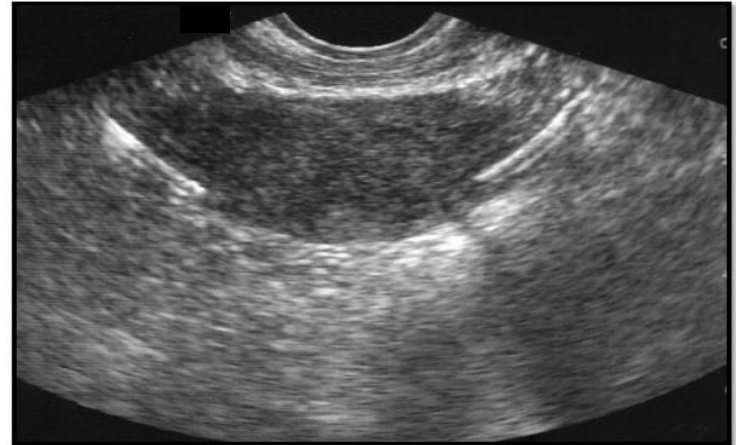
TVU  
(at 3 months postplacement)

- In certain circumstances (according to the TVU/HSG Confirmation Test Algorithm), TVU may be performed as a first-line confirmation test three months after a bilateral insert placement procedure
- TVU should not be used as the Essure Confirmation Test if the placement procedure was difficult, including:
  - Concern at the time of placement of possible perforation due to excessive force required for insert delivery and/or a sudden loss of resistance
  - Difficulty identifying the tubal ostia during placement due to anatomical variation or technical factors such as poor distension, suboptimal lighting, or endometrial debris
  - Physician is uncertain about placement

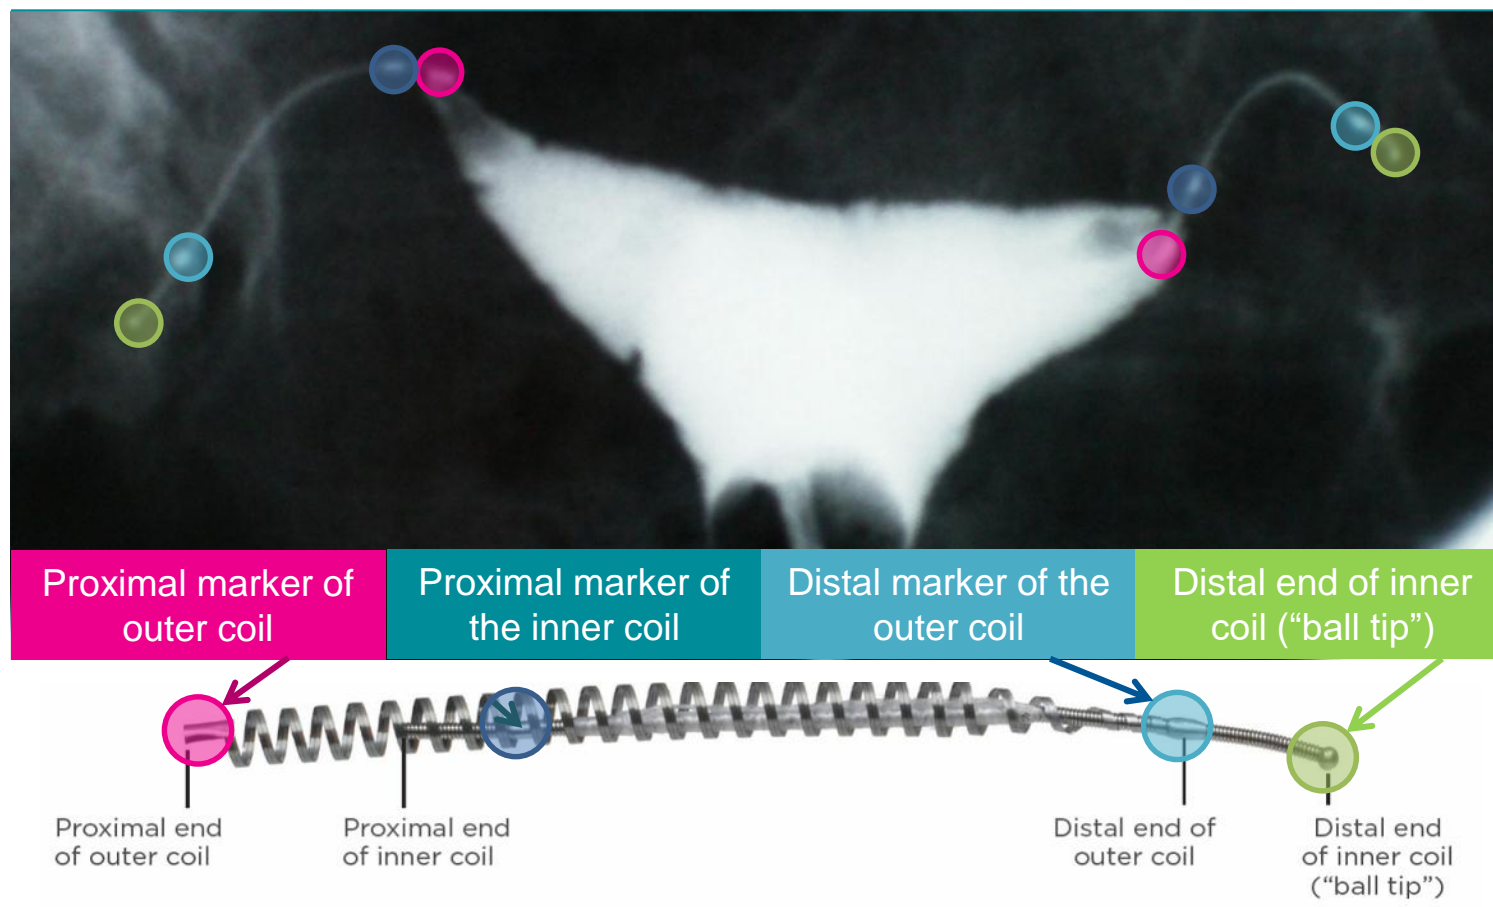
# Radiographic Markers: Modified HSG

- First image captured, before injecting contrast
- Capture image of uterus and inserts without contrast
- Inserts should be clearly seen; note the lie and curvature of the inserts
- Note the 4 radiographic markers on each insert

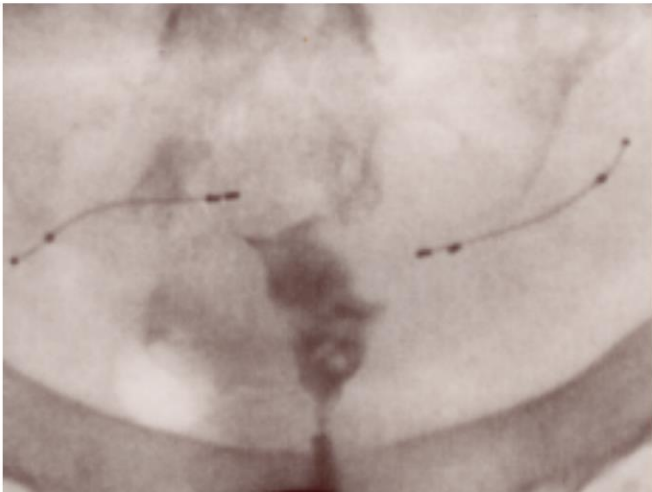
## Minimal fill of the Cavity

- Capture an image of the uterus after a small amount of contrast infusion
- No contrast should be leaking from the cervix if an adequate seal is maintained
- The uterine cavity should start to opacify. Contrast may not have reached the uterine cornua
- If the uterine cavity silhouette is not seen in a nearly A/P projection, adjust the fluoroscopy beam and/or the patient

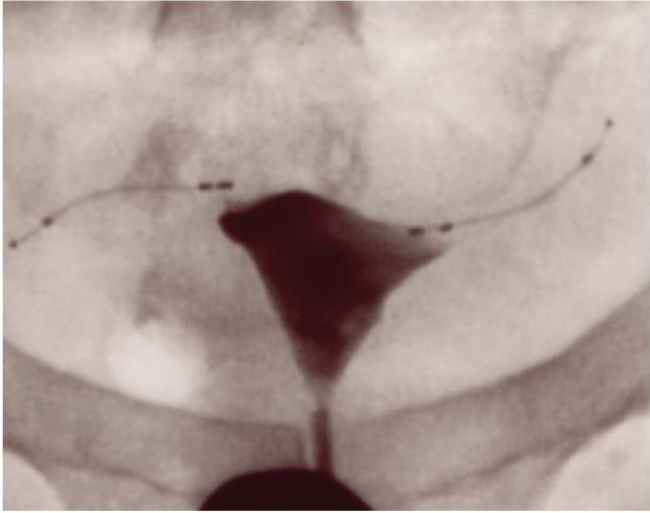
## Partial fill of the Cavity

- Capture an image of the uterus when it is nearly full of contrast or opacified
- The cornua may not yet have been adequately distended
- Proximal portions of the Essure® inserts may not yet be obscured by the advancing contrast

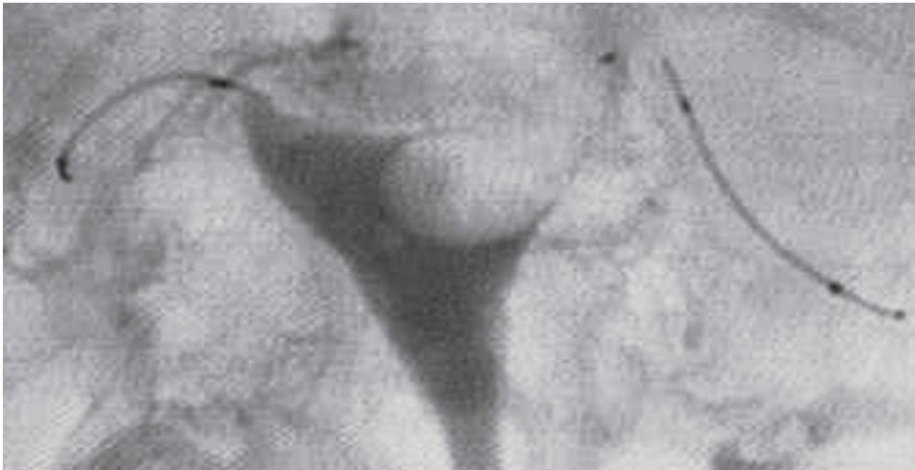
Filling defect in the left cornua

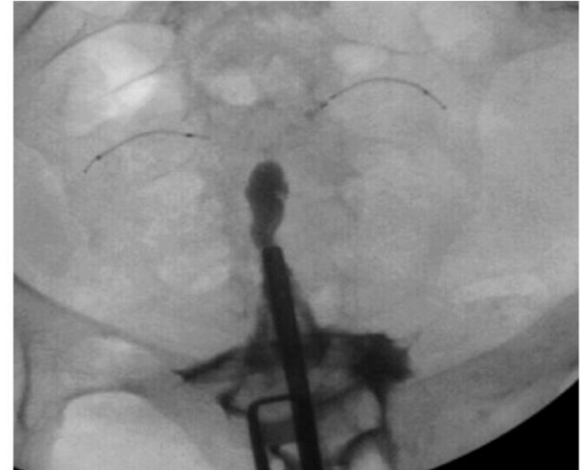
Inadequate filling

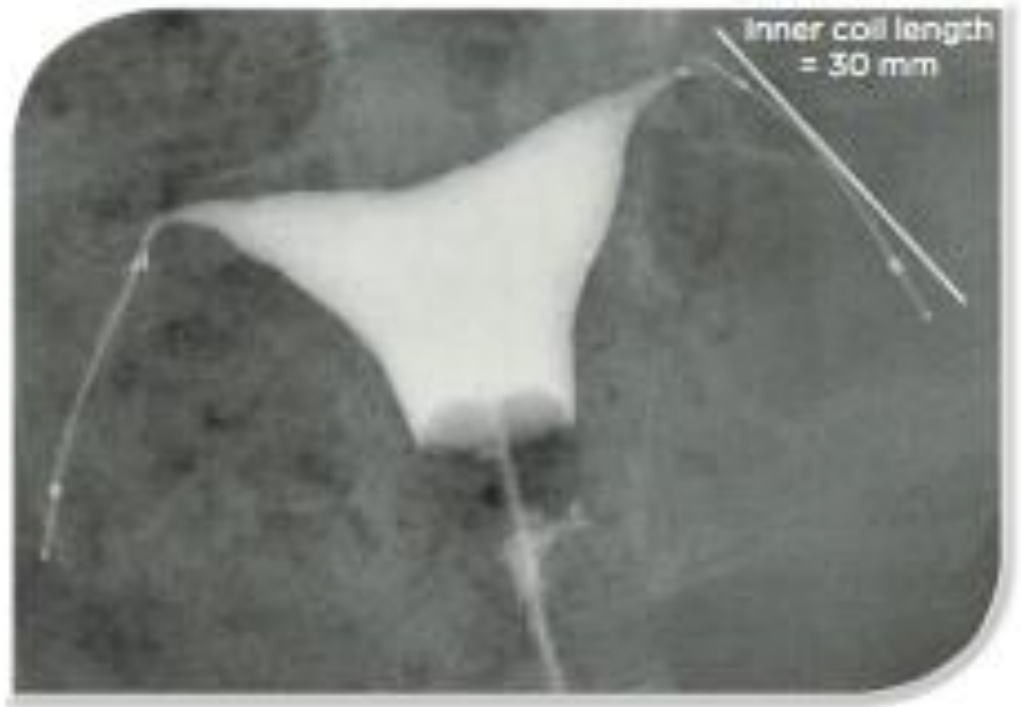
1. Using the inner coil as a point of reference
  - The inner coil measures 30 mm in length (most commonly used method)
2. Calipers
3. Using the distal 2 markers as a measuring reference point
  - The distance between the 2 distal markers measures 5 mm in length

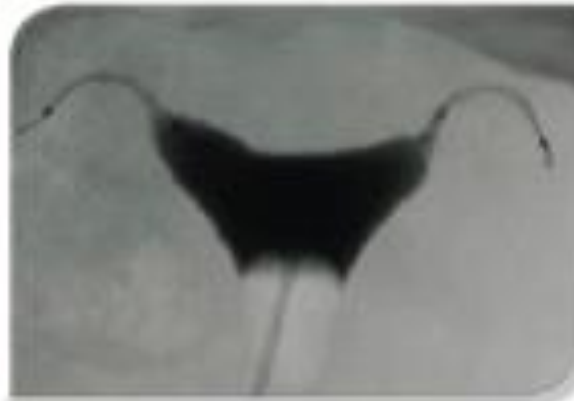
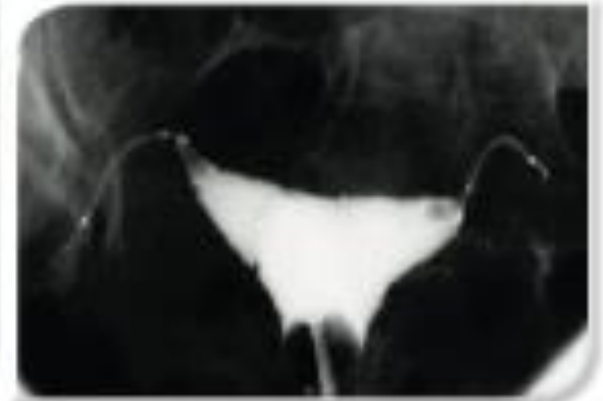
# Satisfactory Location<sup>1,2</sup>

A satisfactory location is defined as the distal end of the inner coil being within the fallopian tube, with <50% of the inner coil trailing into the uterine cavity, OR the proximal end of the inner coil is  $\leq 30$  mm into the tube from where contrast fills the uterine cornua.

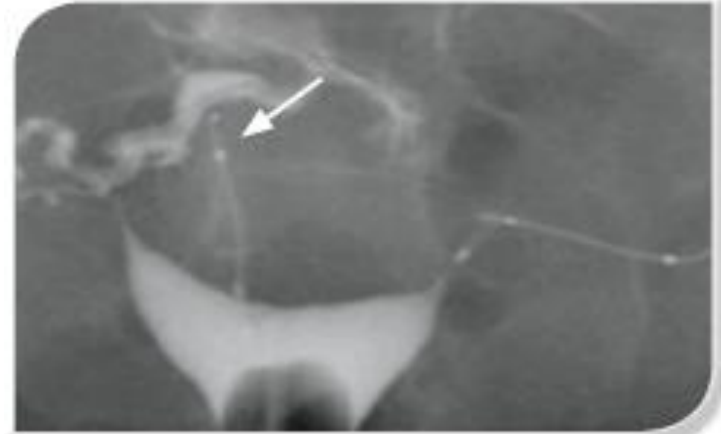
- Advise patient not to rely on Essure® for contraception
- If tube is patent and no part of an Essure® insert is in the fallopian tube, counsel patient on repeat placement procedure
- If tube is occluded, advise patient on potential for false-positive diagnosis of occlusion
- Also counsel patient on incisional sterilization or remaining on alternative contraception
- Location of insert(s) should be evaluated and a decision should be made as to whether the insert should be left in situ or removed

Note: Additional radiographs might include oblique and lateral images, and may be helpful to evaluate location if a perforation is suspected.

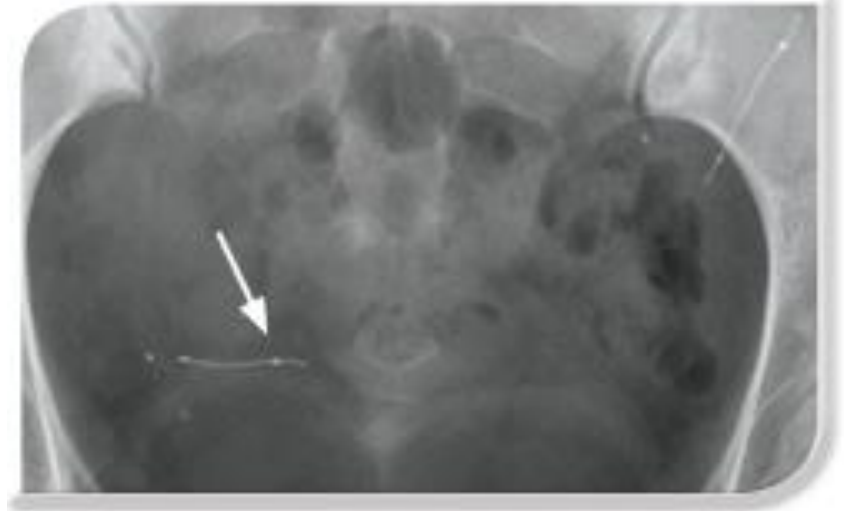
# Managing Unsatisfactory Location: Peritoneal

- Peritoneal location means the insert is found within the peritoneal cavity and is not located within the tube

- Advise patient not to rely on Essure® for contraception
- If tube is patent and no part of an Essure® insert is in the fallopian tube, counsel patient on repeat placement procedure
- If tube is occluded, advise patient on potential for false-positive diagnosis of occlusion
- Also counsel patient on incisional sterilization or remaining on alternative contraception
- Location of insert(s) should be evaluated and a decision should be made as to whether the insert should be left in situ or removed

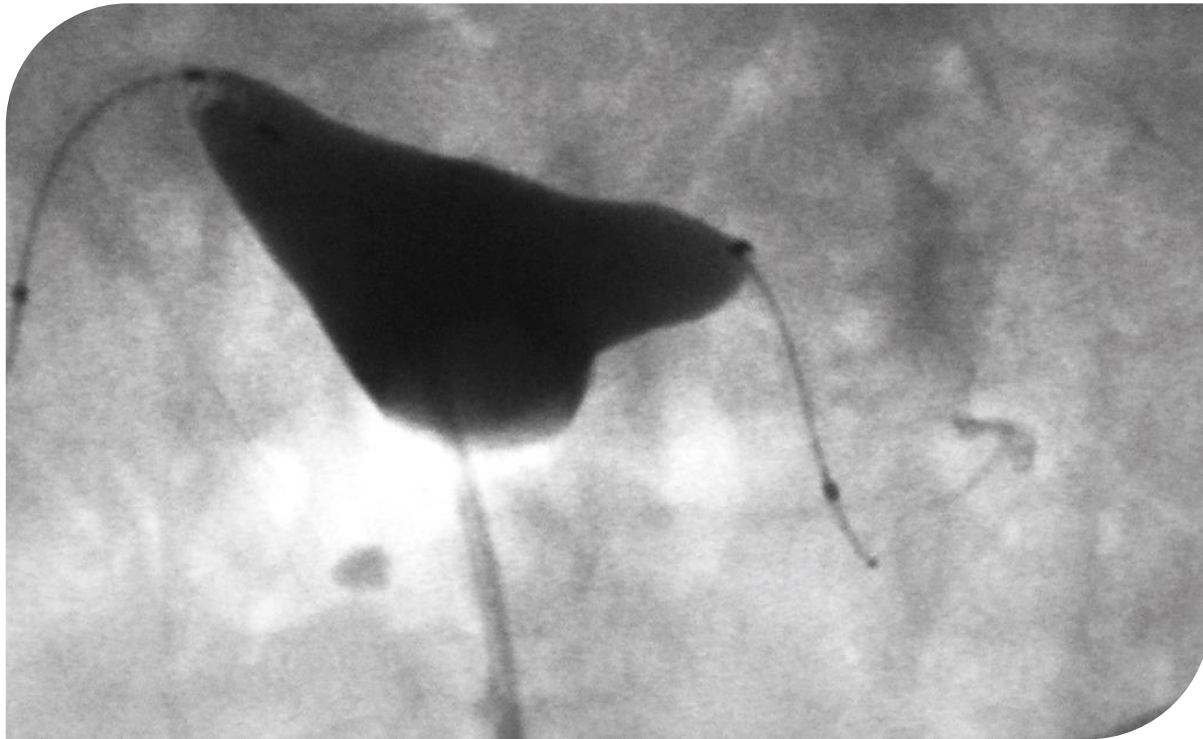
Unsatisfactory occlusion is noted when contrast is visible beyond the distal end of the outer coil or in the peritoneal cavity.

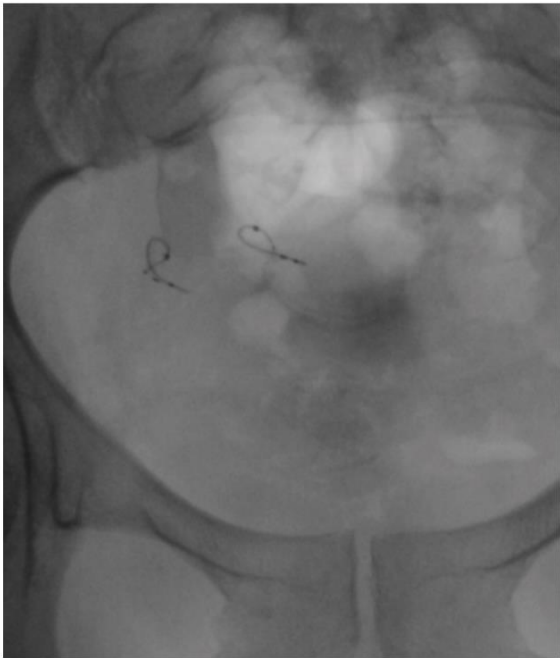
## Case #3

Scout image

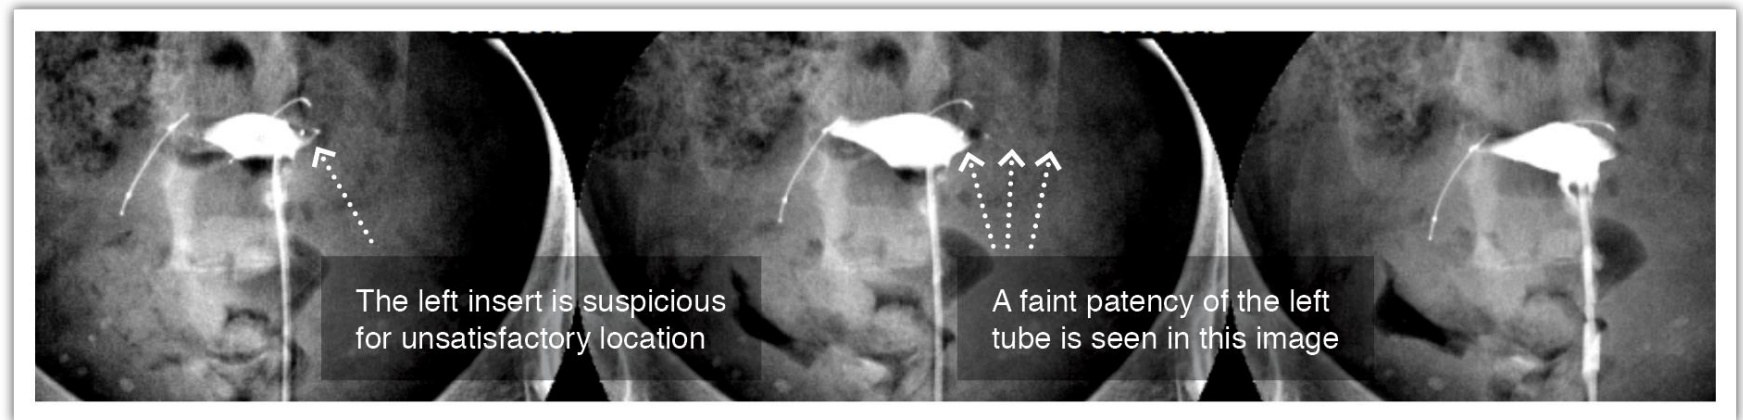
## Case #7: Perforation

Radiology report noted bilateral occlusion of tubes. Patient told to rely. Patient returned to doctor 12 weeks pregnant 18 months after Essure® placement

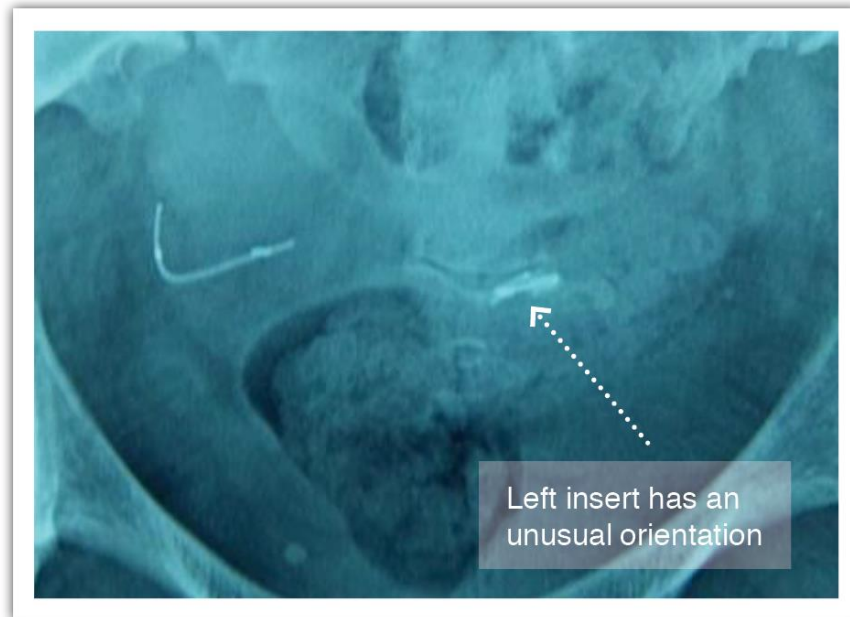
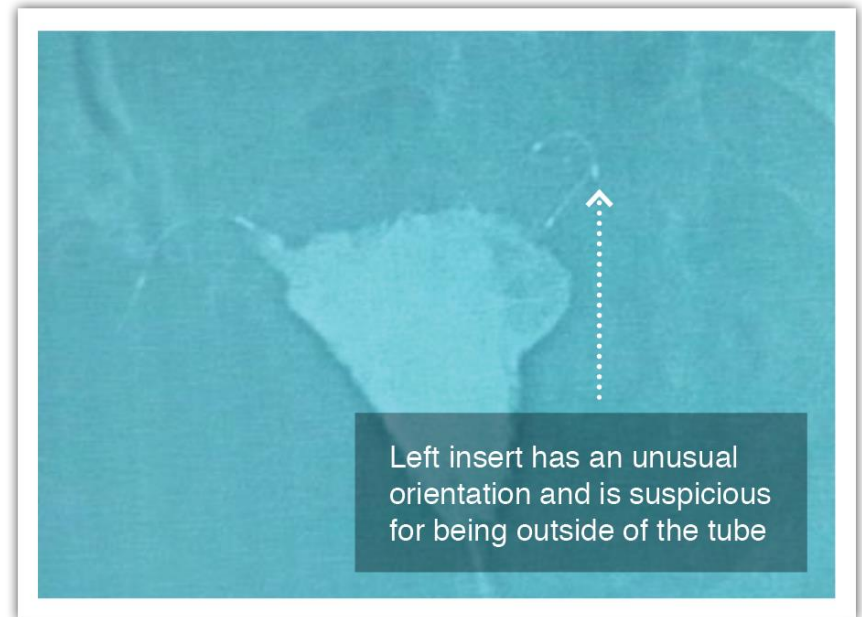
# Case #11: Perforation

Radiology report noted two inserts with bilateral tubal occlusion. Patient told to rely on Essure® for contraception. She returned to her MD six months later and was diagnosed with an intrauterine pregnancy

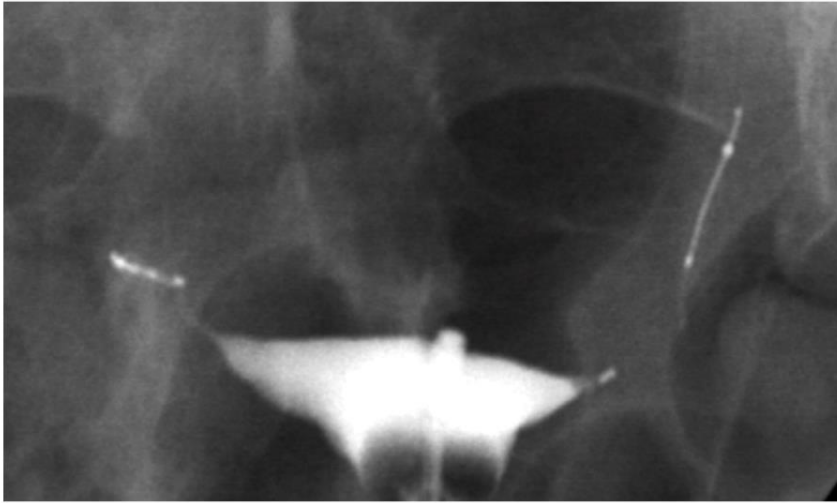
## Case #14: Additional Views May Be Needed

Radiologist was concerned regarding the possibly fractured left insert and the shortened length of the right insert

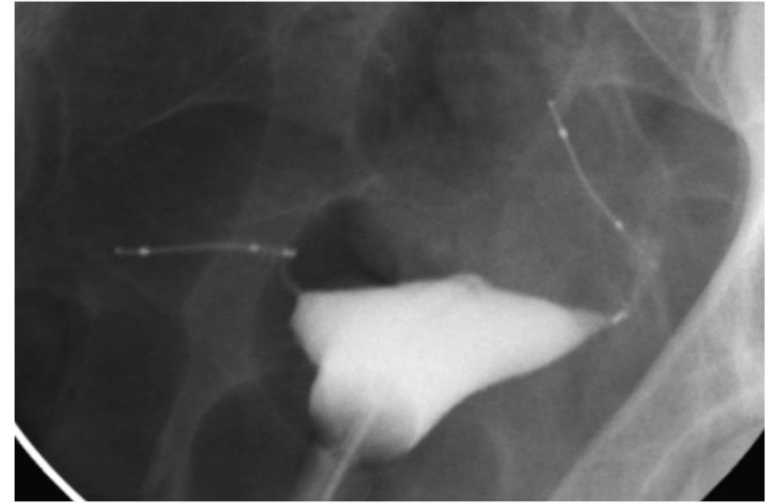
In the additional views, the right insert appears to meet the criteria for satisfactory location and the left insert, though slightly distal, also meets the criteria for satisfactory location. As contrast tracks through the proximal portion of the insert, the stretched outer coils become highlighted

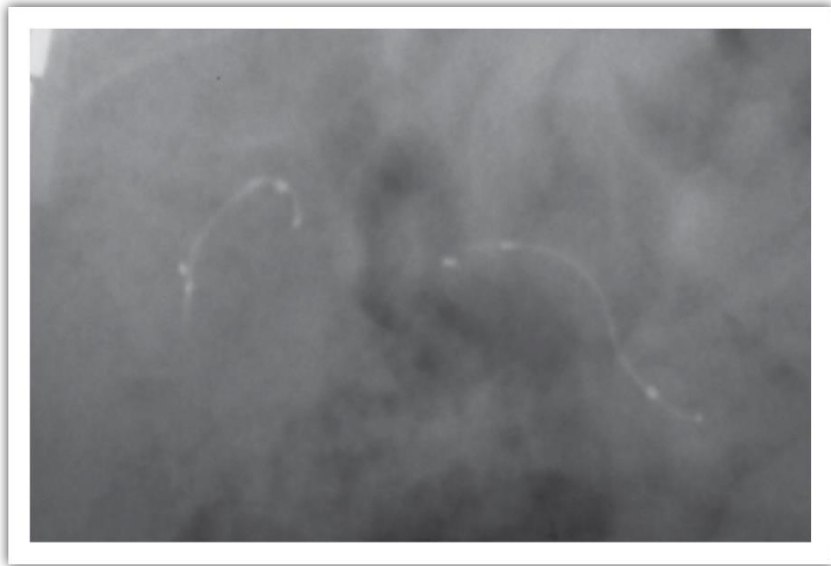
## Case #18

Radiology report notes “fallopian tubes are occluded at the cornua bilaterally.” Patient told to rely on Essure® for contraception

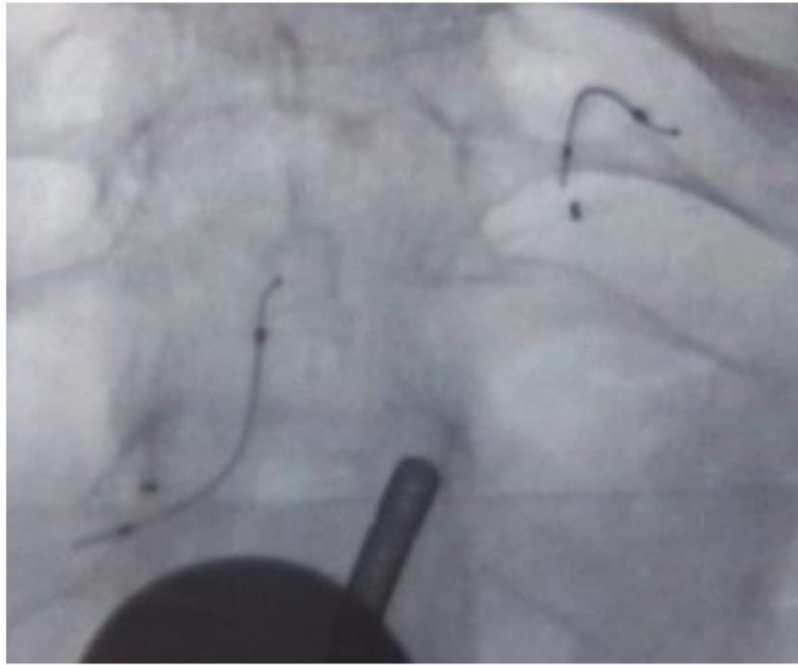
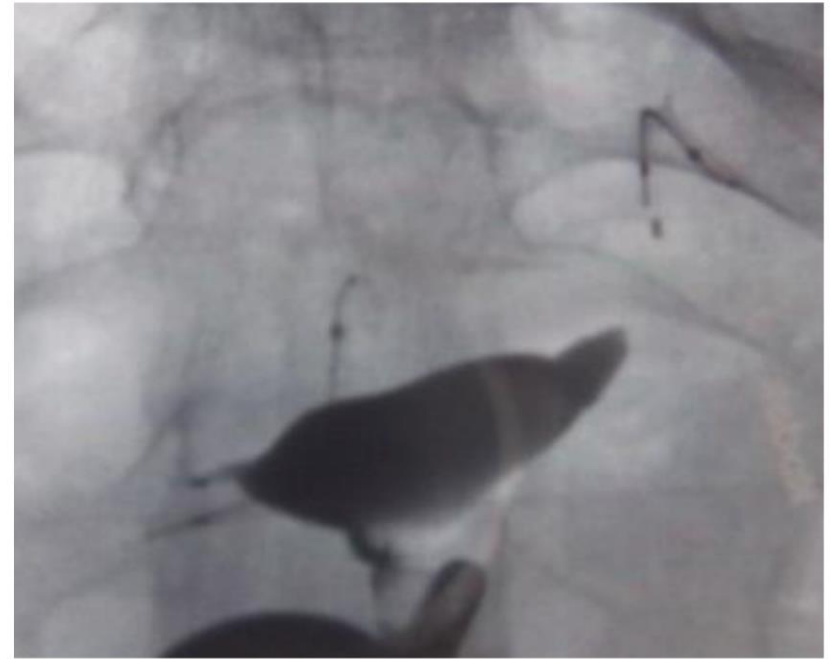
## Case #24

MD did not note difficulty with placement and noted 3 trailing coils were seen from the right and left ostia after placement

The radiology report noted that two inserts were seen, and bilateral tubal occlusion was confirmed. The patient was told that she could rely on Essure® for contraception

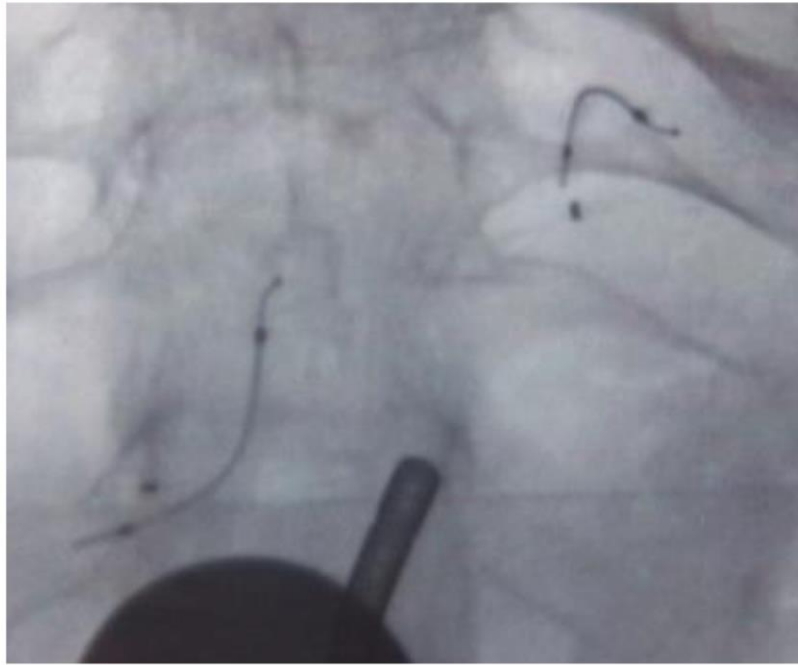
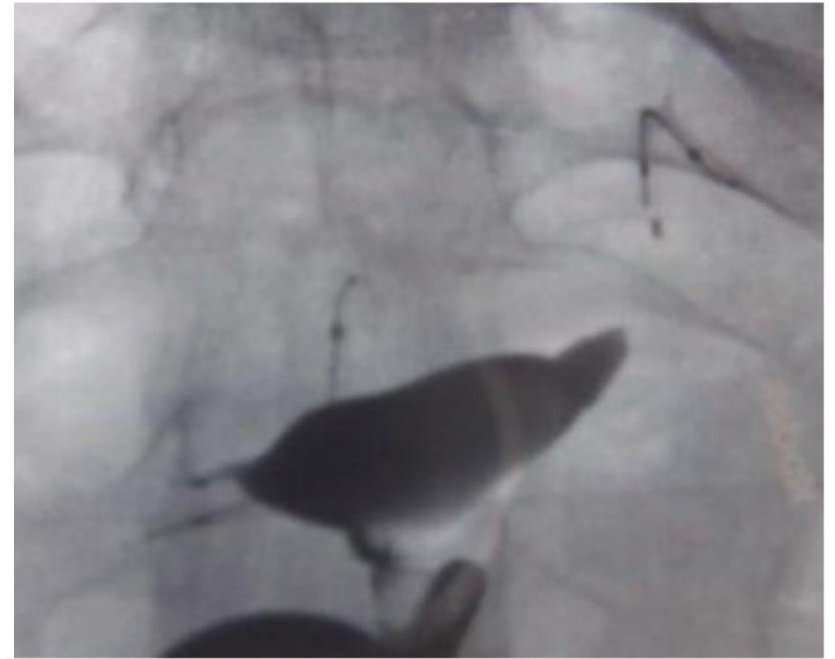
## Case #24: Perforation

Patient returned to MD 3 years after placement with positive IUP

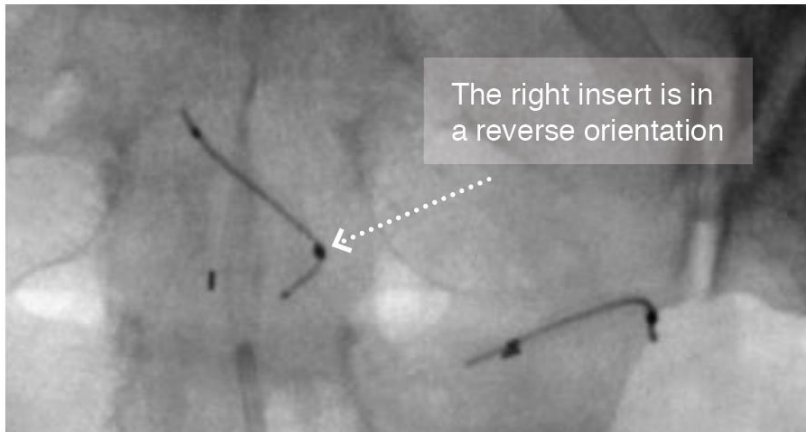
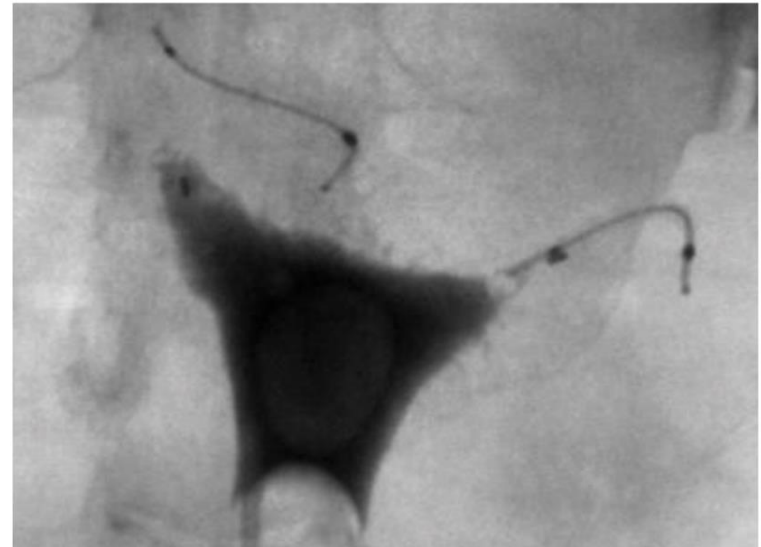
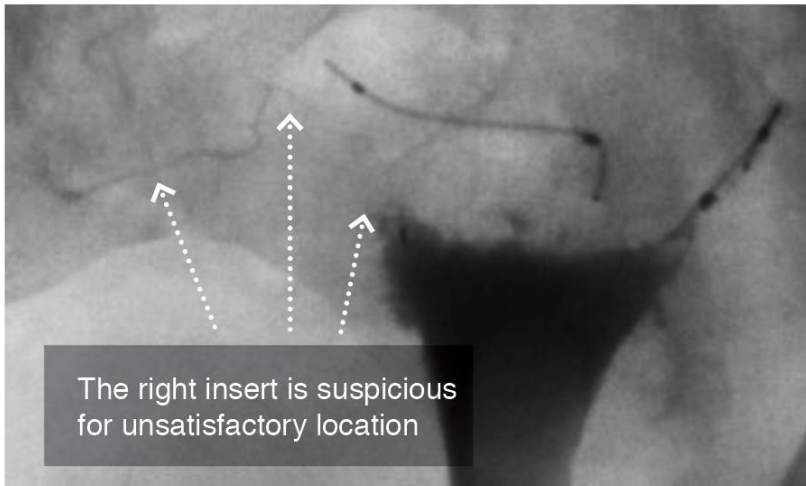
## Case #26: Perforation

Radiology report noted, “slightly atypical configuration of the right insert with apparent bilateral tubal occlusion.” Patient was told that she could rely

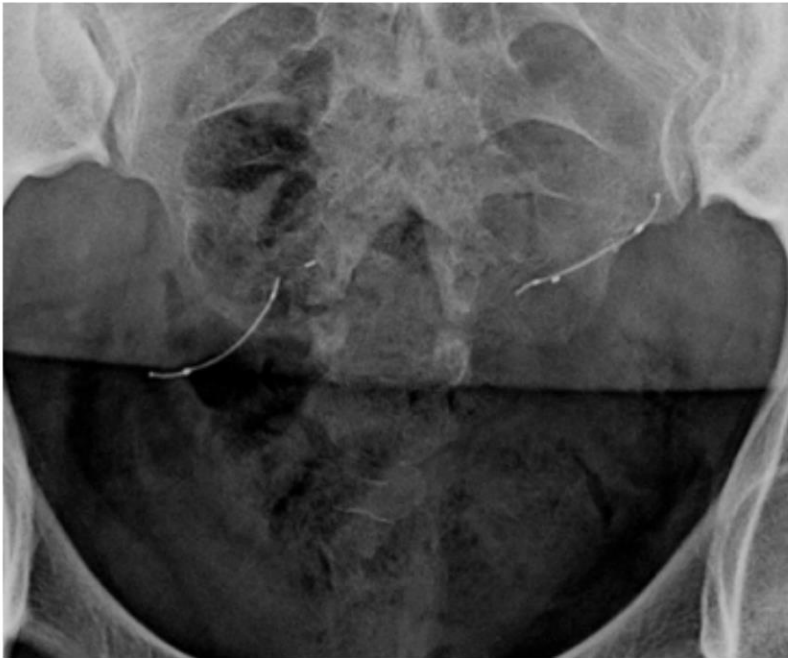
## Case #27: Stretched Outer Coil

Right insert appears “fractured”

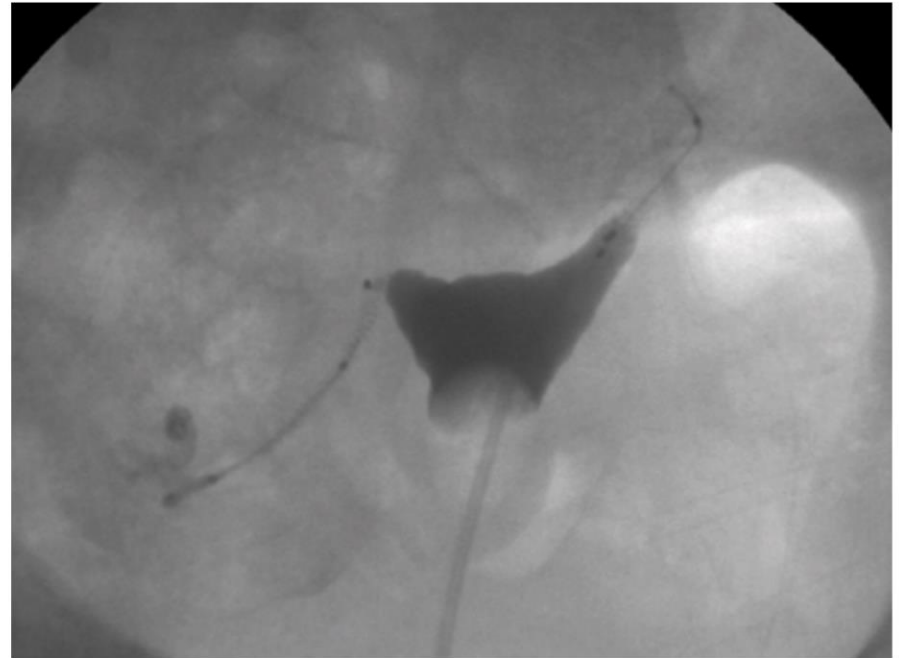
Stretching of outer coils can be seen when contrast tracks through the insert

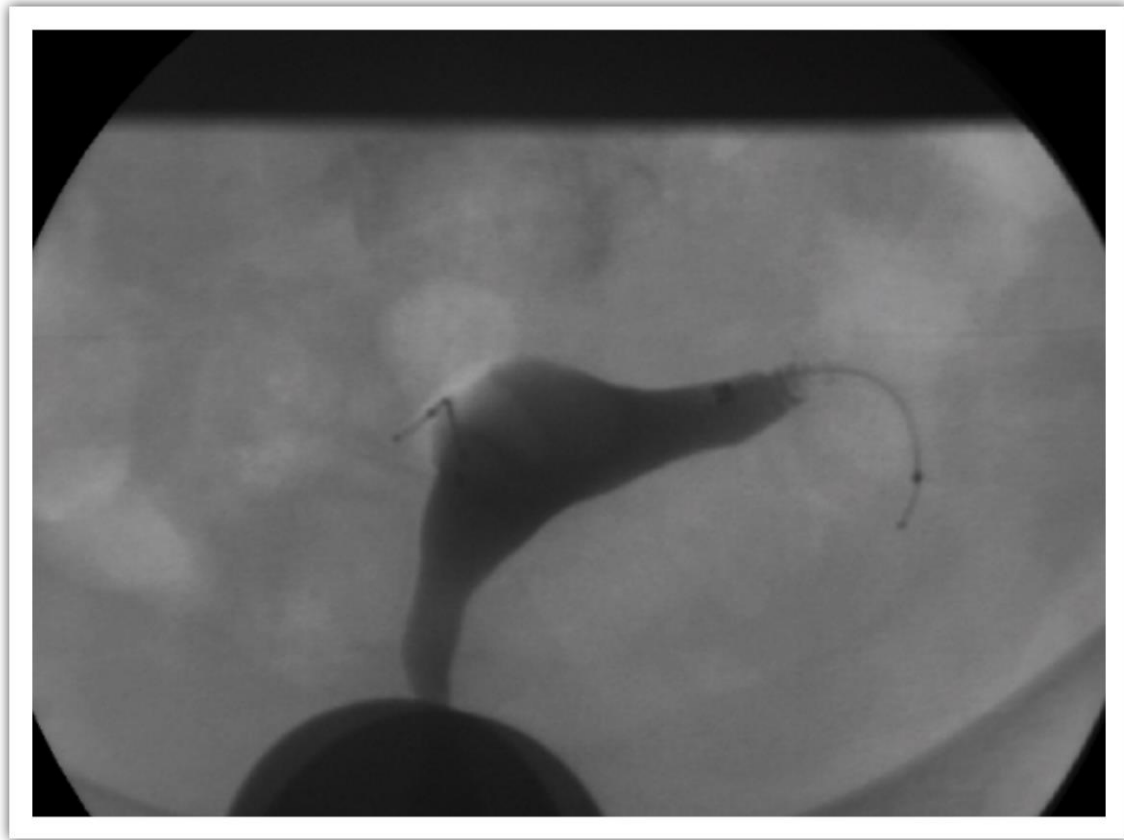
## Case #30: Expulsion

MD states that patient had Essure<sup>®</sup> placed 4 years ago and she documented 9 trailing coils on left and 12 trailing coils on right. Patient recently returned to clinic with 1 device that she states expelled during her menstrual cycle. A repeat modified HSG was ordered

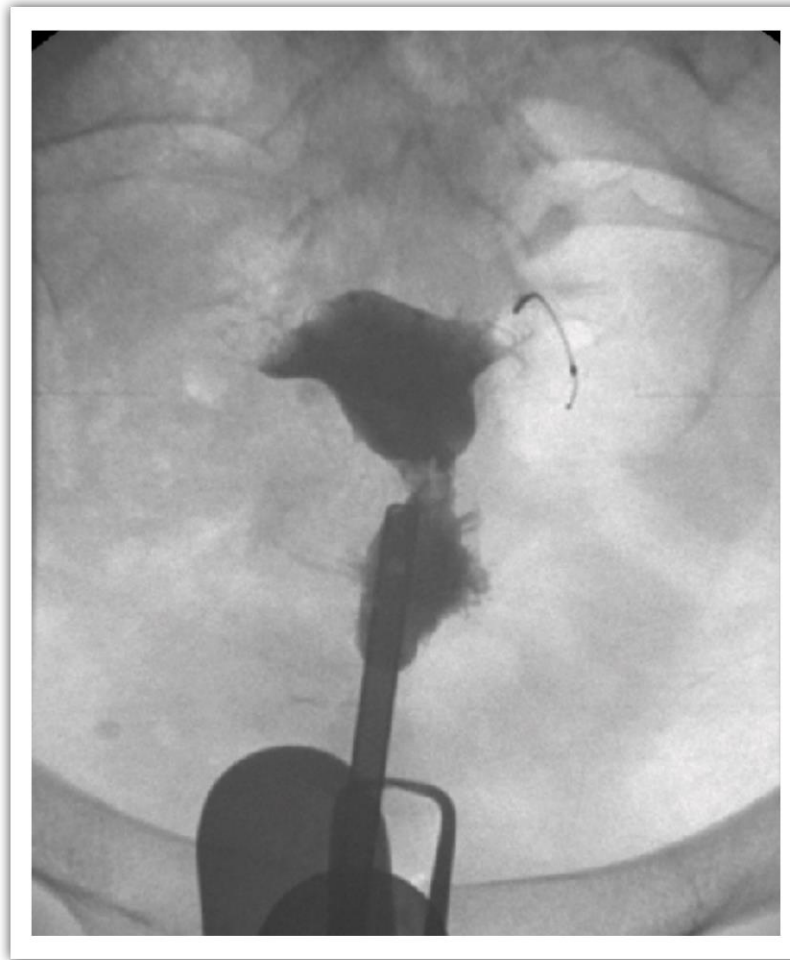
## Case #30: Expulsion

Modified HSG after expelled insert
